# NEW OZ TIMBER FLOORING

## **TEST REPORT**

REPORT NUMBER 180803003SHF-BP-1

Issue Date:	2018/8/14	Intertek Report No.	180803003SHF-BP-1
Applicant:	NEW OZ TIMBER FLOORING		
Applicant Address:	2/262 PARRAMATTA ROAD GRAN	IVILLE, 2142 NSW AUS	STRALIA
	Performance testing Stone Floor

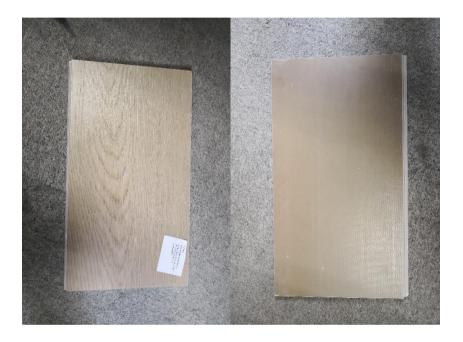
#### **APPENDIX: SAMPLE RECEIVED PHOTO**

SAMPLE ID	MODEL	SPECIFICATION
S180803003SHF.001	1600*180*8.0mm	/
