NEW OZ TIMBER FLOORING

TEST REPORT

180814010SHF-BP-1

Applicant: NEW OZ TIMBER FLOORING
Applicant Address: 2/262 PARRAMATTA ROAD GRANVILLE, 2142 NSW AUSTRALIA**SUBJECT:** Performance testing
Stone Floor

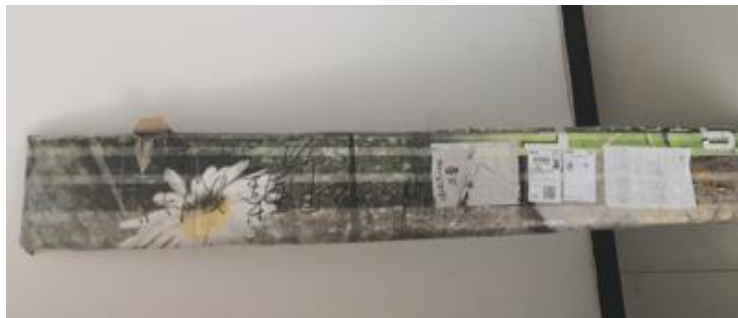
APPENDIX: SAMPLE RECEIVED PHOTO

SAMPLE ID	MODEL	SPECIFICATION
S180814010SHF.001	1600*180*8.0mm	/
