## TEST REPORT

No. : XMIN190902311CCM

Sample Name : STONE FLOOR  
Material : Stone powder, Plastic  
Spec. : 8mm

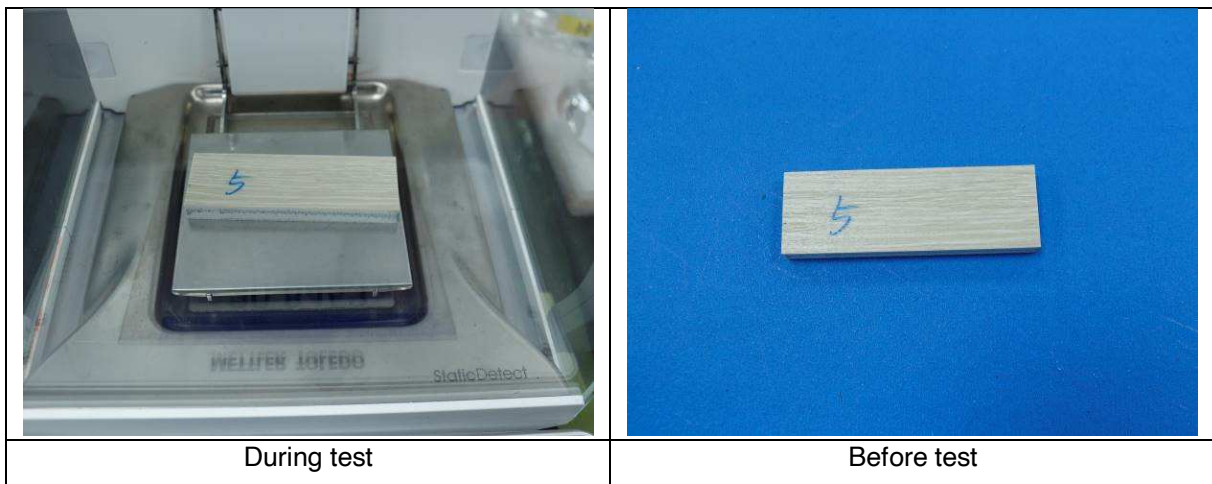
Test Photo:

Test Item: Water Absorption

Specimen: 75.8mm×25.4mm×7.8mm

Immersion condition: 23±1°C, 24h

During test

Before test

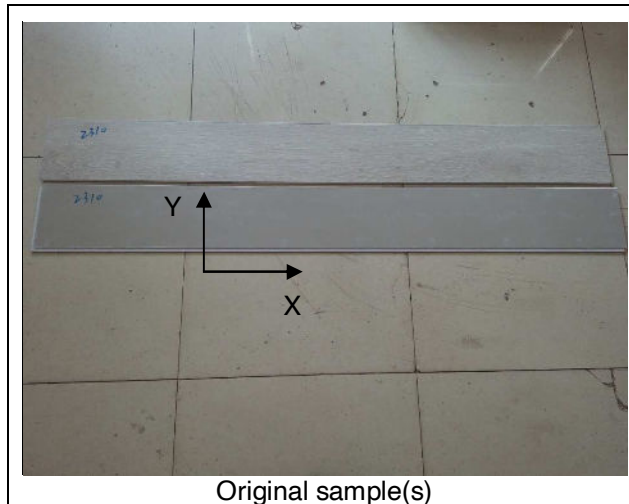
### Specimen photograph(s):

Original sample(s)

Flooring, See the photograph(s).

Note: 1. All test specimens were cut from the samples, see the photograph(s).

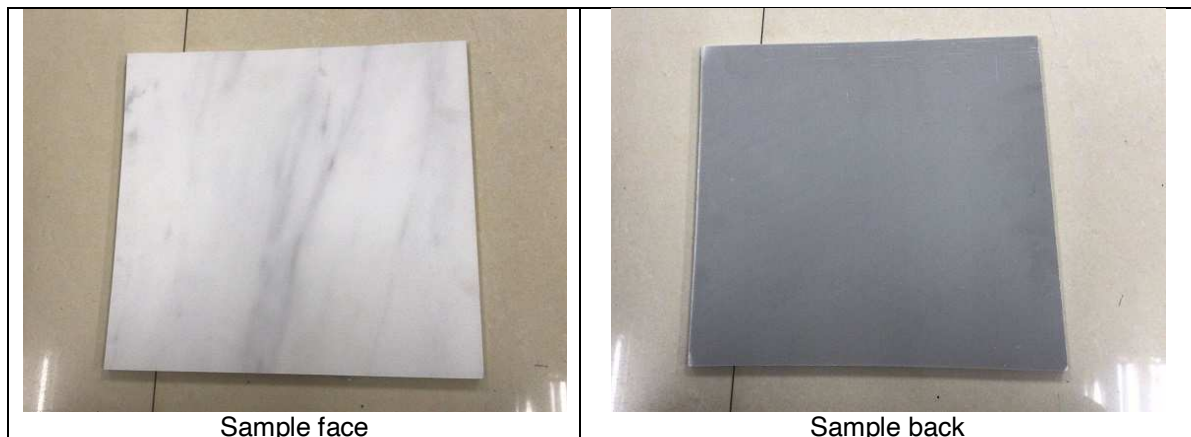
## Sample Photo(s):

Sample description: Panel (see photo)
